# 2017 Honda CR-V LX

## Pre-Purchase Inspection

Standard Package

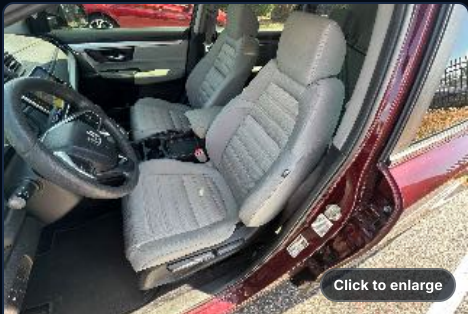
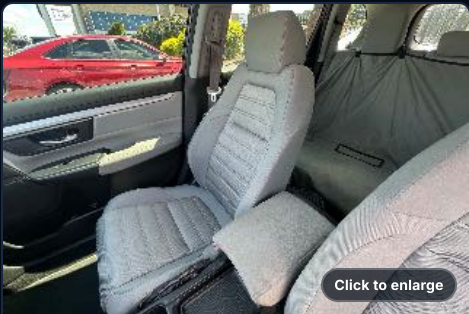
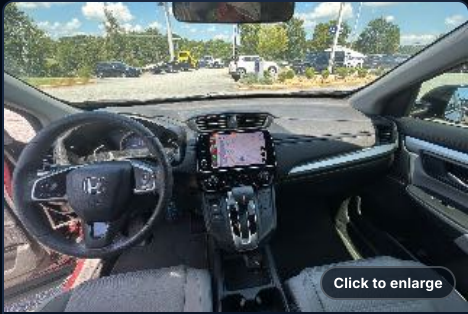
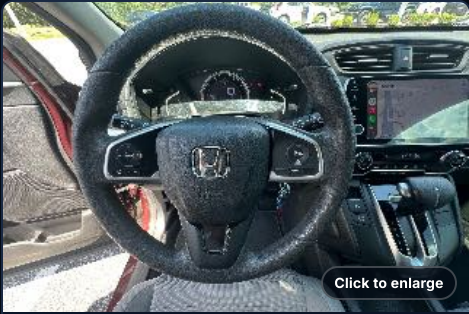
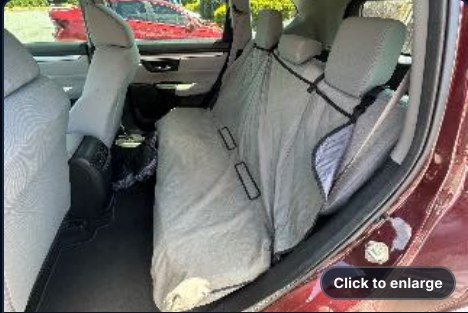
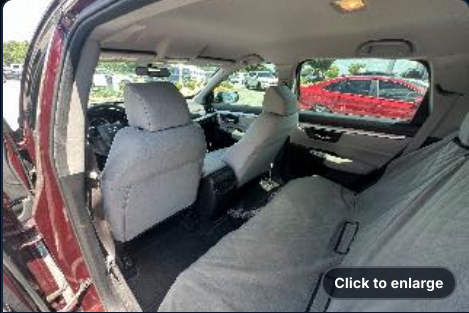
INTERIOR

Interior is very clean no bad odors, however, there's a lot of pet hair and a deep vacuum or cleaning will be needed.
