# 2017 Honda CR-V LX

## Pre-Purchase Inspection

Standard Package

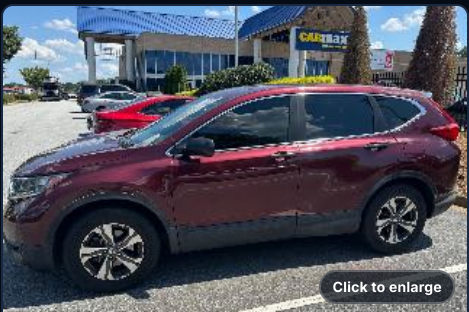
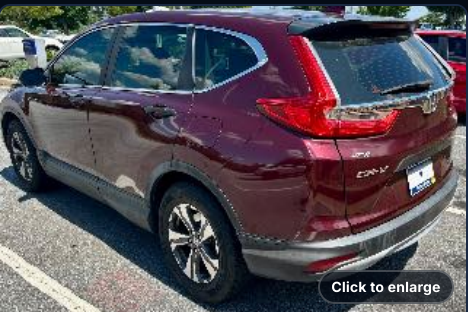
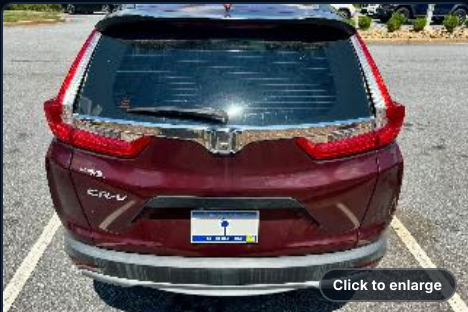
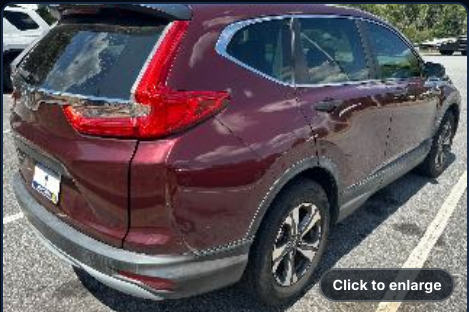
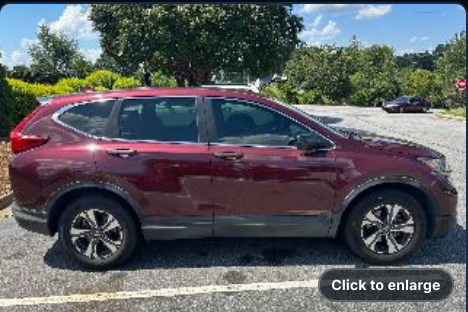
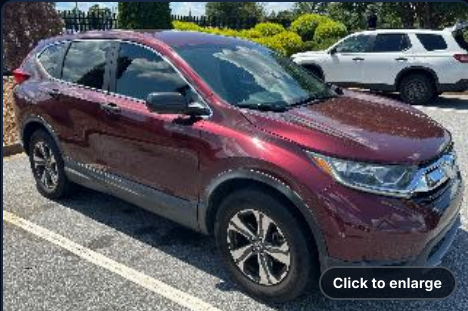
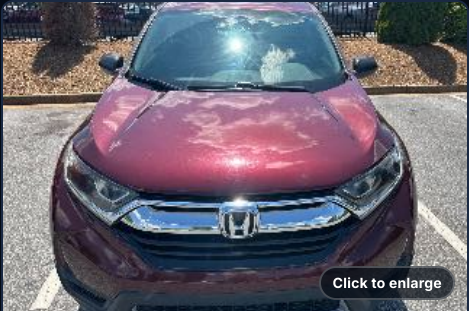
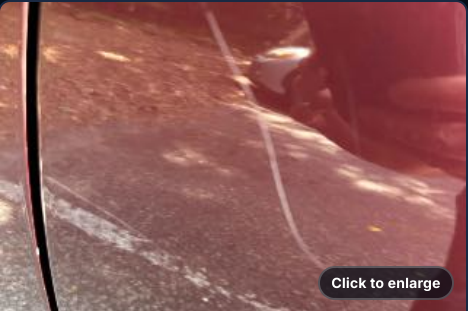
Driver's door sticks a little bit as it opens and closes. This indicates prior bodywork and potentially the need for an adjustment of the hinges or latches.

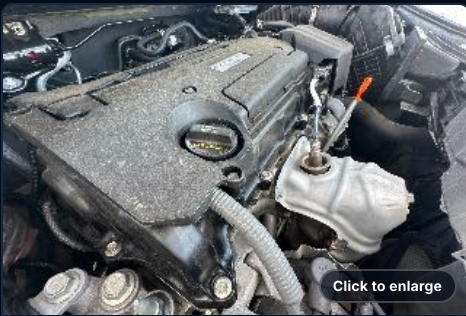
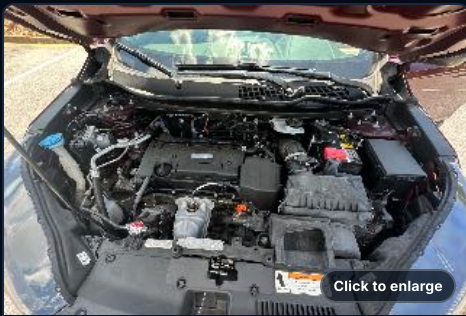
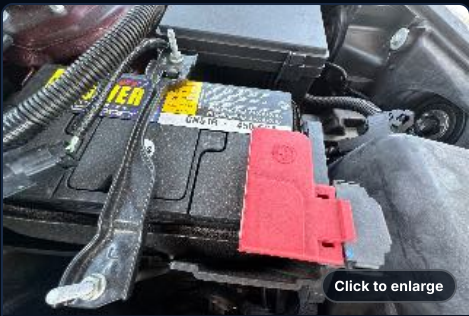
Although the coolant looked fine, the coolant level was low. This indicates a potential leak, although no obvious leaks were observed at the time of the inspection.

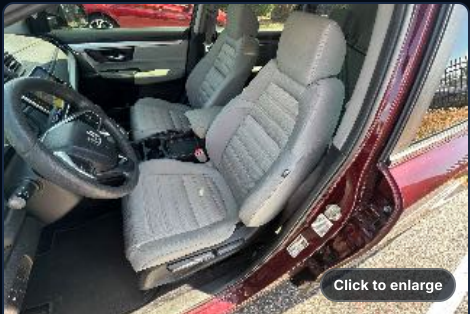
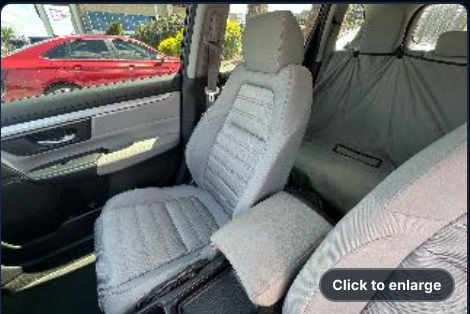
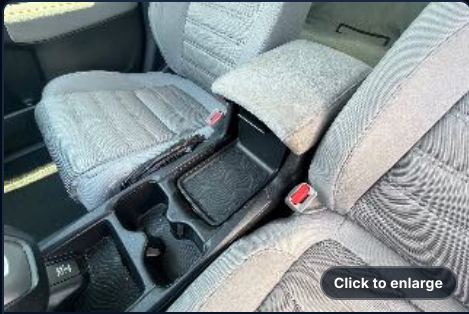
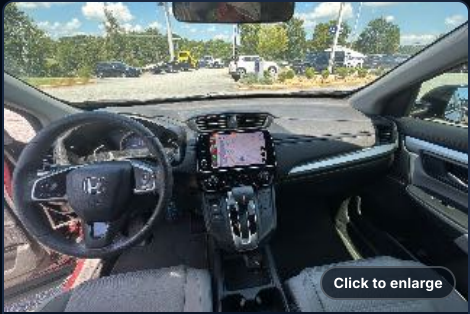
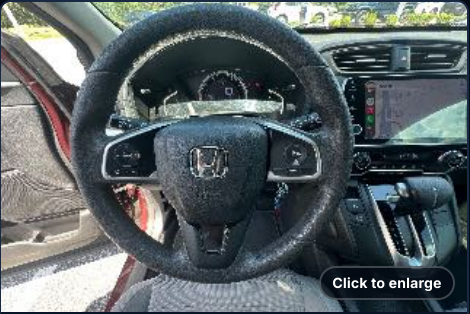
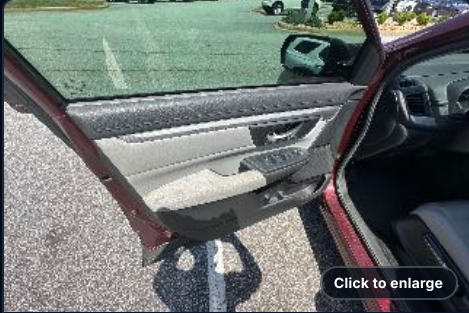
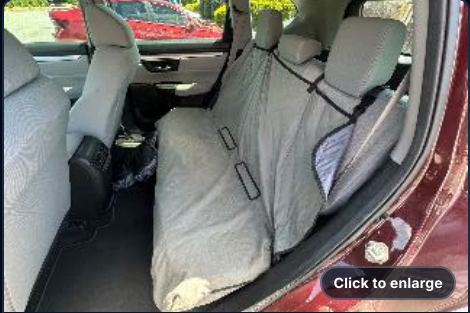
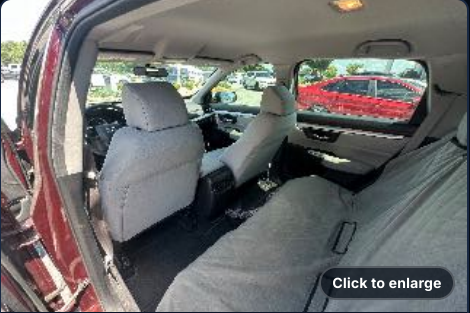
Interior is very clean no bad odors, however, there's a lot of pet hair and a deep vacuum or cleaning will be needed.

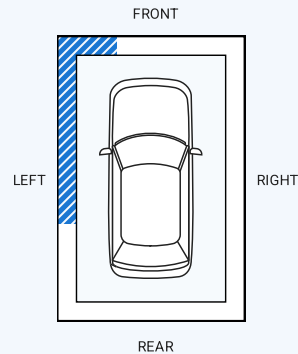
**Damage Location**

- Vehicle involved in a sideswipe collision with another motor vehicle
- Damage to left side
- Damage to left front
- Airbags did not deploy
